# Crashworthiness of buses: Analysis of European data and suggestions for improvements

Ingeborg S. Hesjevoll,  
Researcher at the Institute of Transport Economics

ETF Road Collision Safety Event  
Rome, September 24<sup>th</sup> 2025

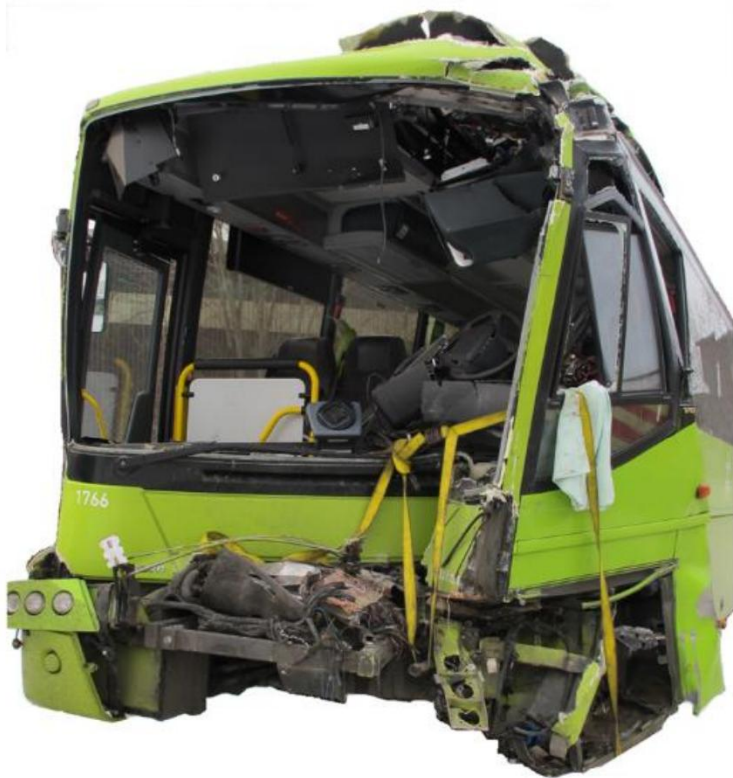
*Figure 5: Damage to the front of the westbound bus. Photo: AIBN*

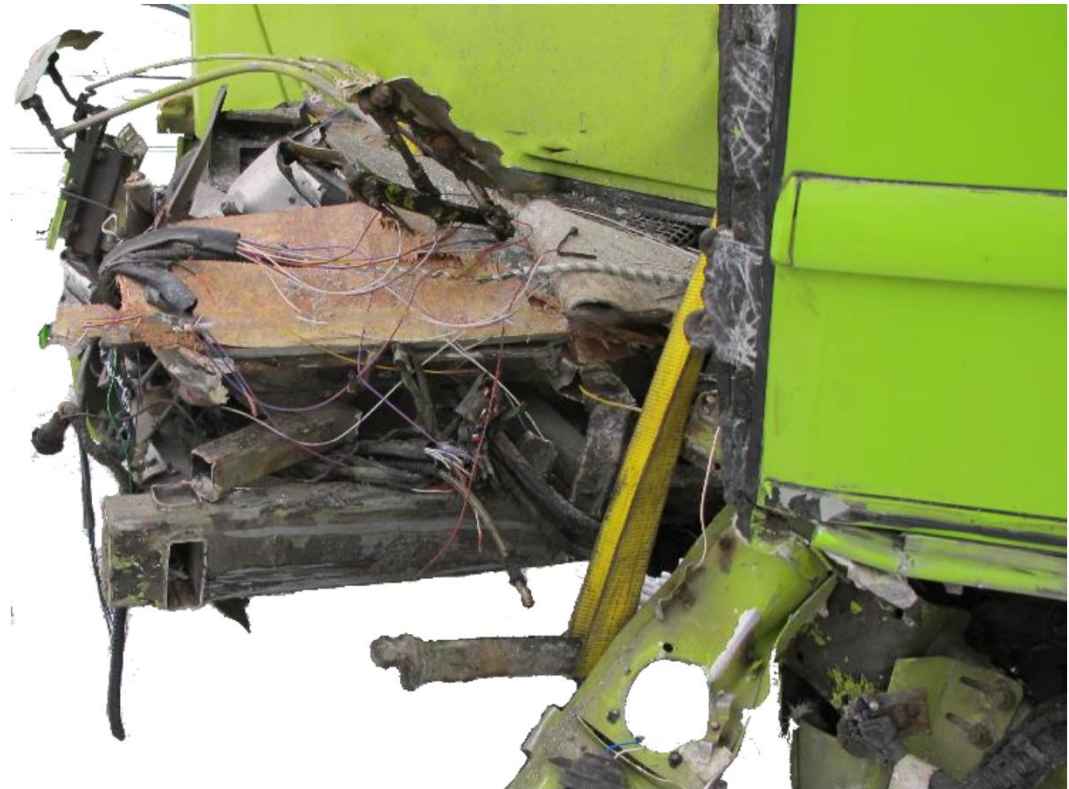
*Figure 6: Cross-beam severed on the left-hand side, seen from the side. Photo: AIBN*

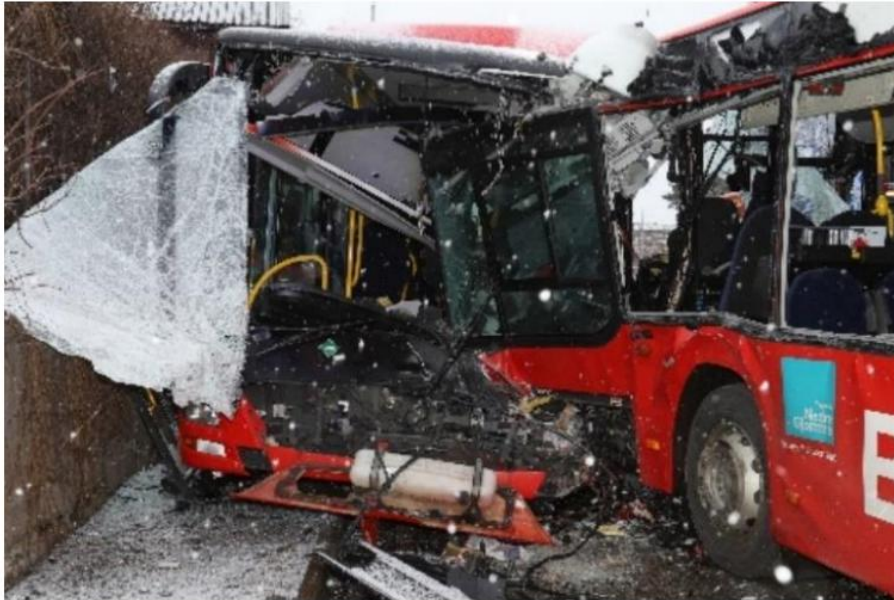
Figur 3: Buss 113 sett forfra. Foto: Politiet

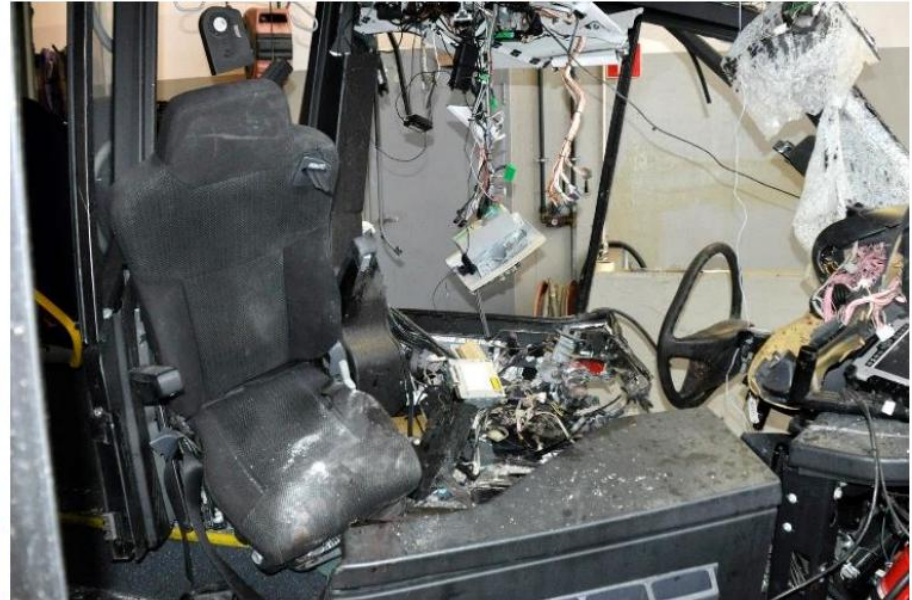
Figur 4: Førerplass i Buss 113. Førerstol er presset bakover som følge av inntrengingen. Foto: SHK

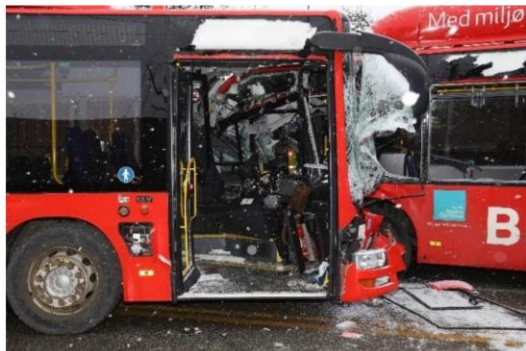
Figur 5: Buss 5 sett fra siden. Foto: Politiet

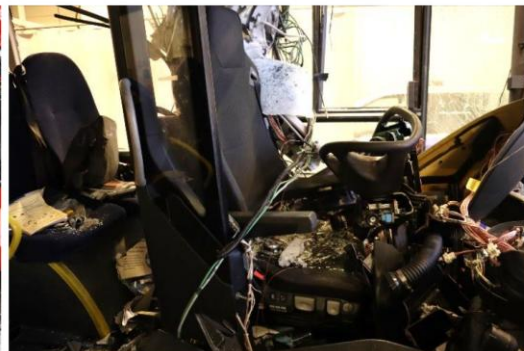
Figur 6: Førerplass i Buss 5. Førerstol intakt. Foto: SHK
